SLURRY FEED AND DISCHARGE ISOLATION CONTROL

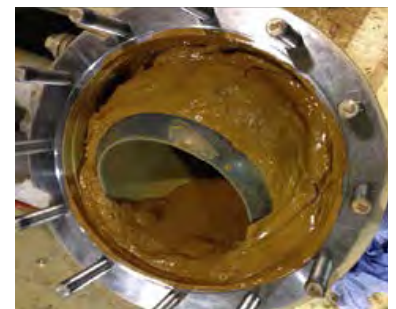
Eroded and Corroded Ball Valve

isolation valves fail to close and stall, the abrasive slurry will quickly erode the ball valve leading edges, such that the valve will be unusable and require expensive repairs that often need to be completed thousands of miles from the mine site. When this happens, the valve is taken off-line which decreases the level of safety in the POX operation.

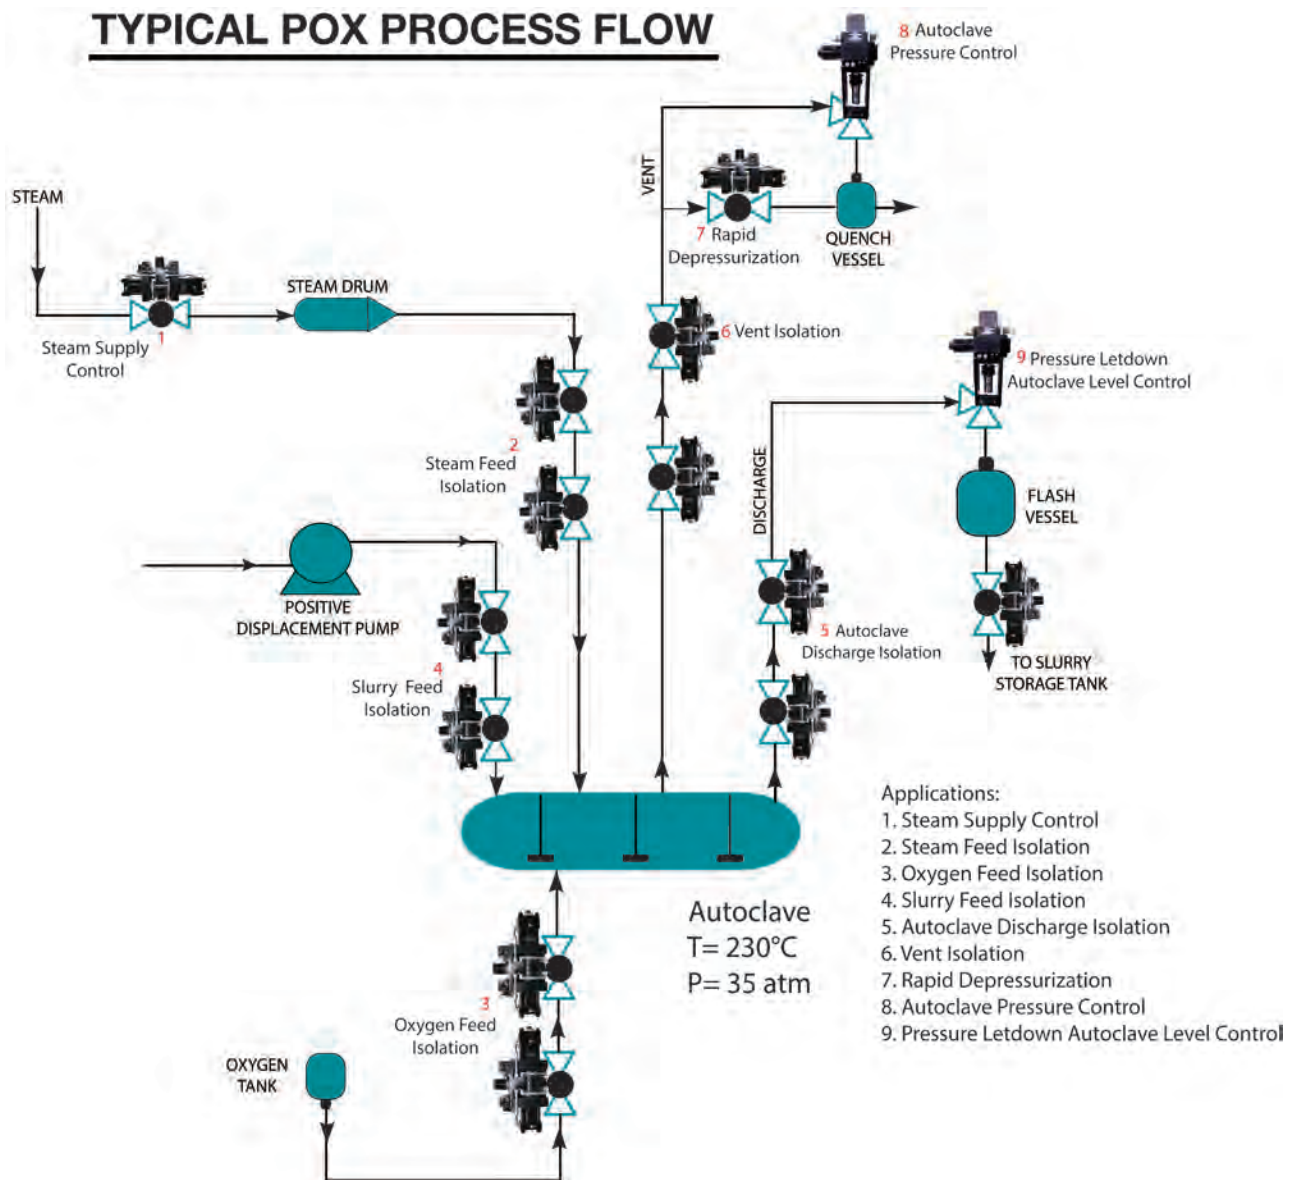
improved block valve positioning reliability were necessary and REXA's solution was self-contained [X3 MEGApac Rotary Actuators](#) based on the company's [Electraulic® Technology](#).

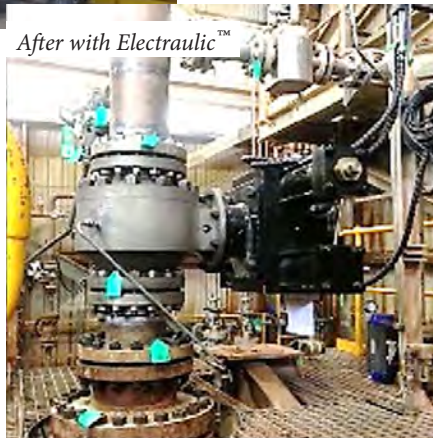
The customer received eight fail closed and eight fail last REXA Electraulic™ Actuators. This design allows for a much smaller footprint and lighter weight (11Xs) actuation engineered for use with high torque and fast closing speeds on block valves in POX autoclaves. REXA's sophisticated electronics allow complex diagnostics and partial stroking for enhancing the operation and service life of the valve.
