SLURRY FEED & DISCHARGE ISOLATION CONTROL

ELECTRAULIC™ ACTUATION

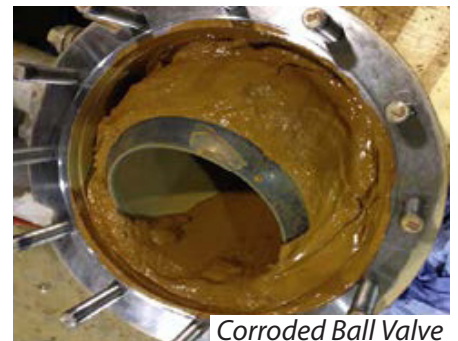
Corroded Ball Valve

corrosion the ball valve encounters. Slurry scale build up around the ball valve and trim increases the breakaway torque. Eventually, this scale may even cause the valve to stall. Should the isolation valves fail to close and stall, the abrasive slurry will quickly erode the ball valve leading edges, such that the valve will be unusable and require expensive repairs that often need to be completed thousands of miles from the mine site. When this happens, the valve is taken off-line which decreases the level of safety in the POX operation.

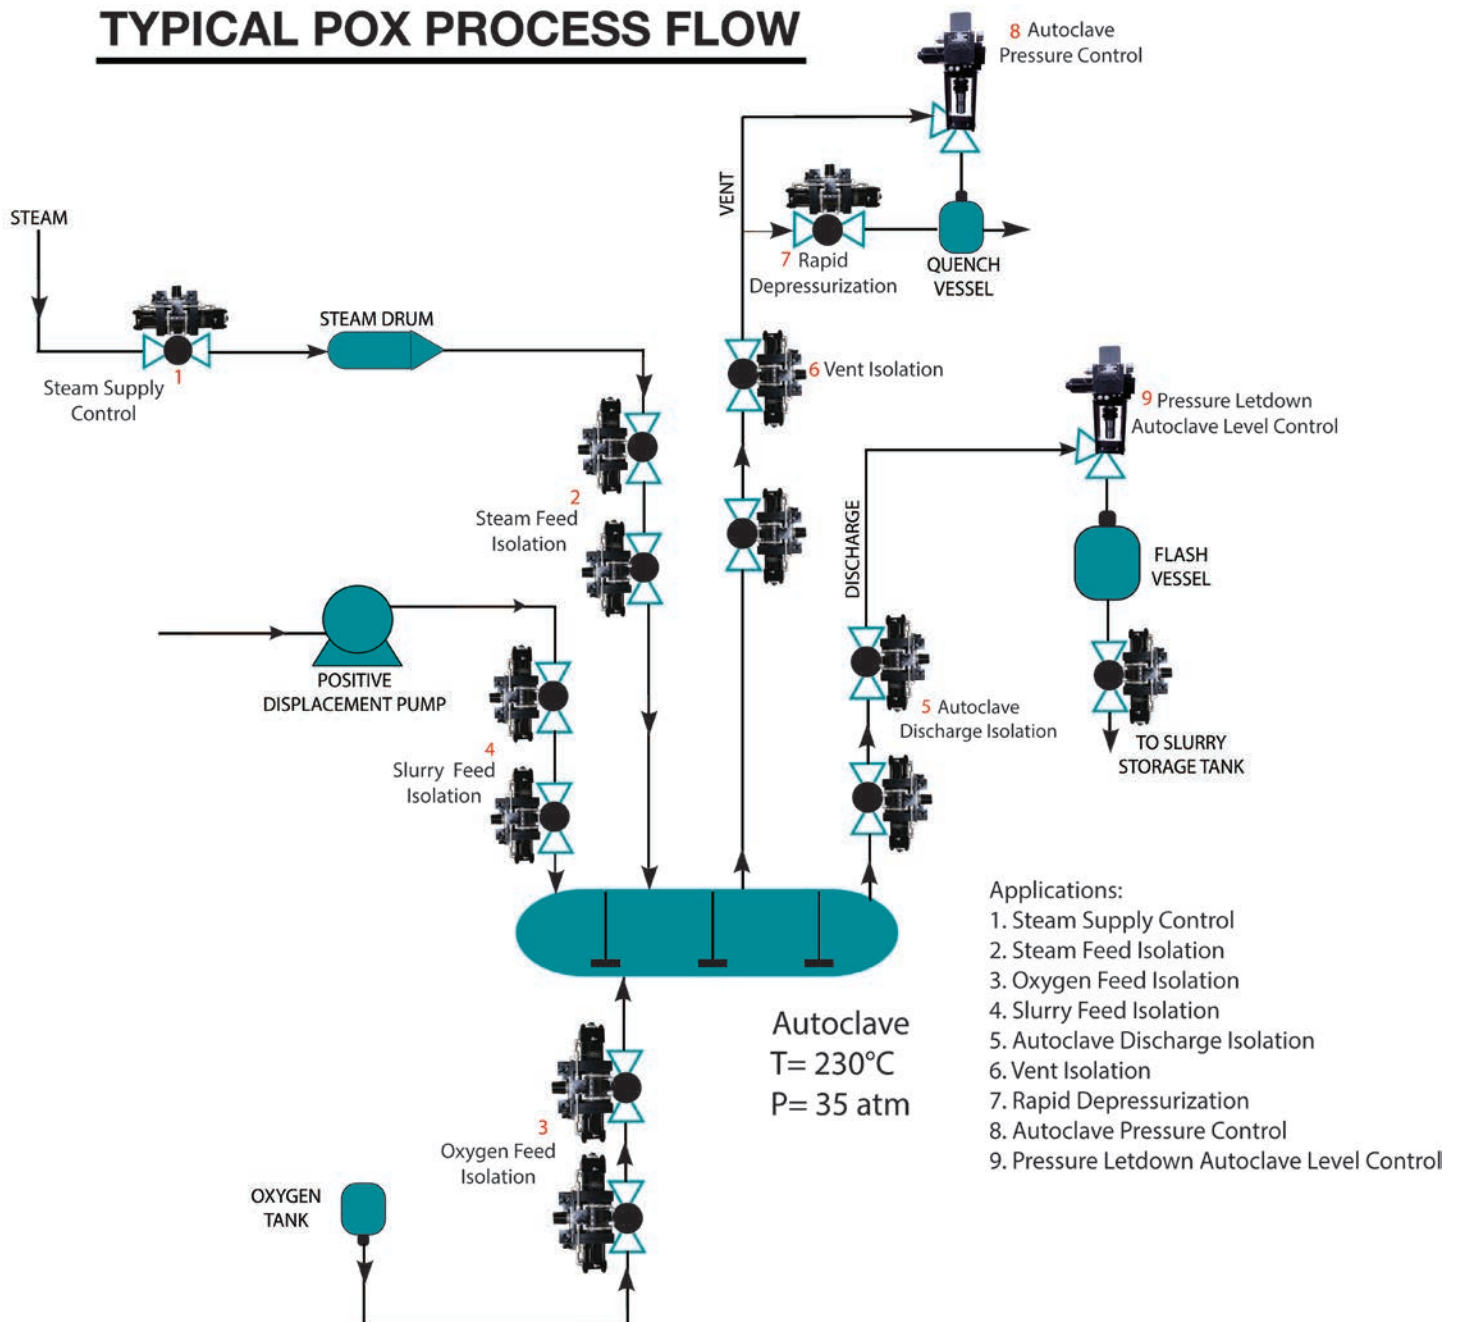
TYPICAL POX PROCESS FLOW

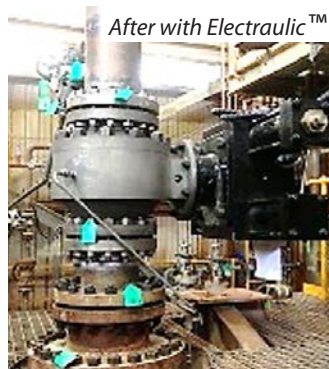
After with Electraulic™

The customer received eight fail closed and eight fail last REXA Electraulic™ Actuators. This design allows for a much smaller footprint and lighter weight (11Xs) actuation engineered for use with high torque and fast closing speeds on block valves in POX autoclaves. REXA's sophisticated electronics allow complex diagnostics and partial stroking for enhancing the operation and service life of the valve.
